Missouri Rural Water Association

SMOKE TESTING FOR I & I WITNESS LOG SHEET

CITY OF Cairo Sheet # 1

Date 10-14-2020 Time 8:45 am Time \_\_\_\_\_

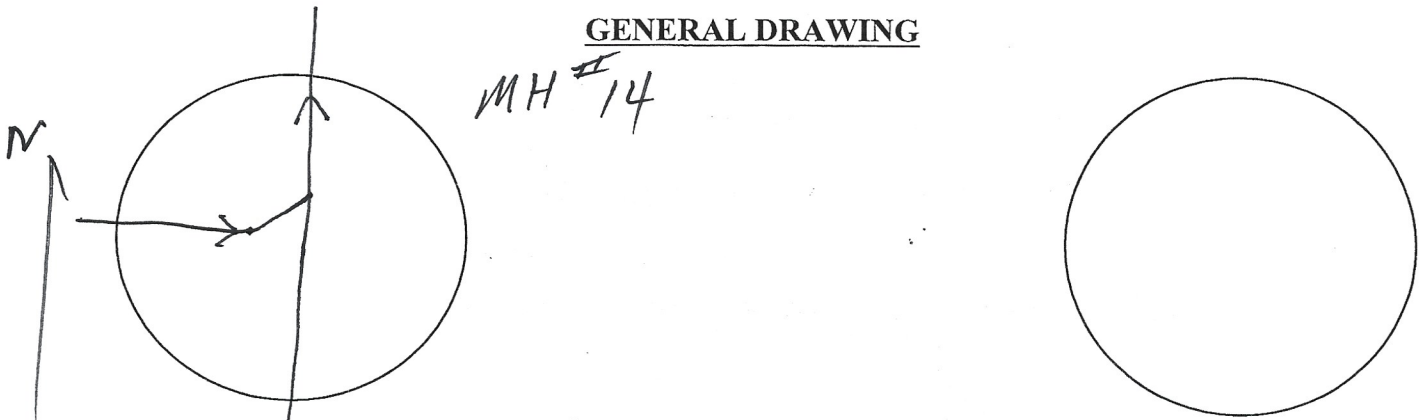
GENERAL DRAWING

| MH# | #1 | <u>MH # 14</u> | <u>1. Seam in MH# 14 leaks some. Sludge is filling inverts + affects drainage!</u> |
| | #4 | | <u>* 2. 2 M/H's on corner of 3<sup>rd</sup> St. near 107 needs seal under frame!</u> |
| | #7 | | <u>* 3. 203 3<sup>rd</sup> St. Leak by STREET in grass area. Possible damage from Fiber project.</u> |
| MH # | #1 | | <u>4. 202 S. Main leak at base of vent pipe + Clo needs capped at N. E. corner of House.</u> |
| | #4 | | <u>5. 109 S. Main St. Condensation line enters sewer service!</u> |
| | #7 | | <u>6. 309 3<sup>rd</sup> St. pipes under Trailer.</u> |
| | #8 | | <u>7. 307 3<sup>rd</sup> St. smoke coming out from under Foundation.</u> |

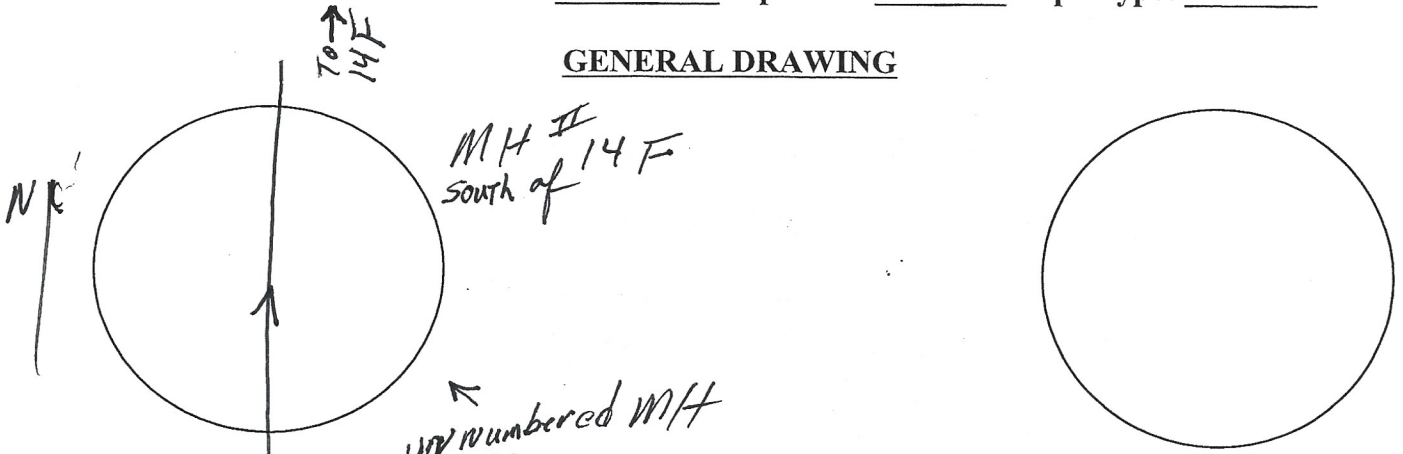
GENERAL DRAWING

| MH# | #1 | * 1. Approx. 150' North of MH is |
| | #2 | a 6" c/o buried off below ground. |
| | #4 | * 2. C/o <sup>below ground</sup> in abandoned lot at SW corner |
| | #5 | of Prather & Scott. intersect. |
| | #7 | 3. bumper hitch bumper w c/o that needs |
| | #8 | extended above ground. |
| MH # | #1 | 4. New construction lot has a c/o |
| | #2 | with a leak in ground where service |
| | #3 | intersects sewer main. |
| | #5 | 5. MH in road ditch across from 117 |
| | #6 | Prather Rd needs INFLOW cover. |

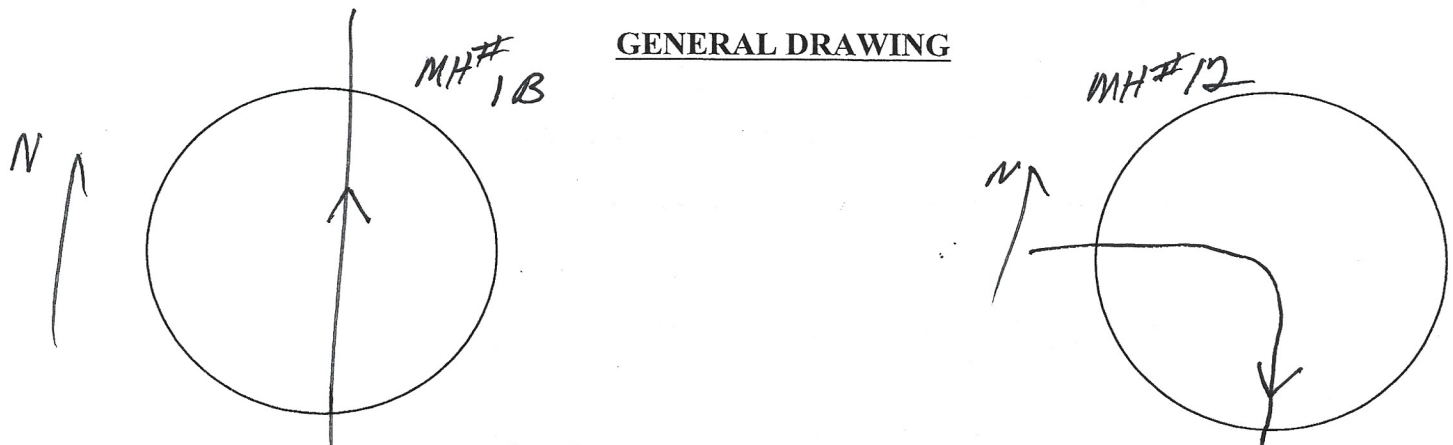
GENERAL DRAWING

| MH# | #1 | <u>MH 1B</u> | <u>1. 221 South Landram St. C/o on North side of house needs capped.</u> |
| | #4 | | <u>2. 105 South Landram C/o <sup>service</sup> South side of house by side walk.</u> |
| | #7 | | <u>3. 103 E. Martin St. C/o needs capped!</u> |
| | #9 | | <u>4. Tom Reinhart's service east of house leaks smoke.</u> |
| | #3 | | <u>1. 406 West Martin St. C/o broke at ground level - Service leak S.E. of house 25'.</u> |
| | #7 | | <u>2. MH on corner of Atters Dr. has leak at FRAMPI</u> |
| | | <u>4. Pester's on Rose Dr. C/o needs capped.</u> | <u>3. 403 Allen Circle 1 C/o East side + 1 C/o NORTH side of house.</u> |

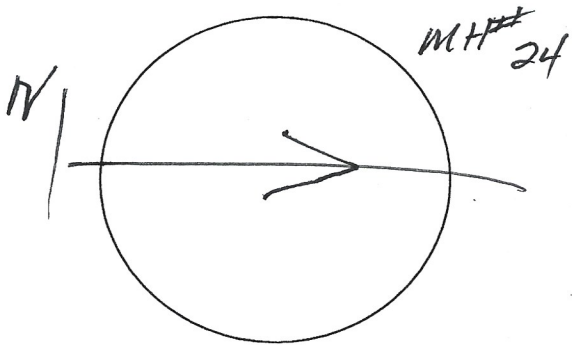
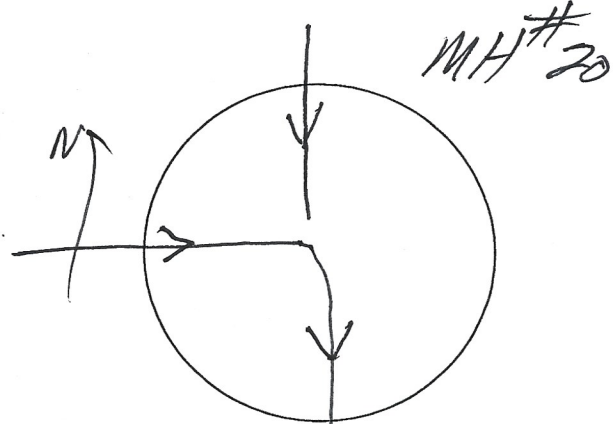
GENERAL DRAWING

| MH# | #1 | <u>MH# 24</u> | <u>1. # 24 Frame needs rescaled!</u> |
| | #3 | <u>*</u> | <u>2. 417 W. Martin St. N. of house 2 C/O's in yard.</u> |
| | #5 | <u>*</u> | <u>3. 411 has a MH in back yard w lid</u> |
| | #6 | | <u>a jar + hose draining swim pool w/</u> |
| | #7 | | <u>pipes stuck in MH. Bad Behavior!</u> |
| MH # | #1 | <u>MH# 20</u> | <u>1. Concrete Pad west of 201 N. Main</u> |
| | #2 | | <u>has pipe taking surface water</u> |
| | #4 | | <u>2. BAPTIST Church NORTHSIDE of Bld.</u> |
| | #5 | | <u>has a drain alt along foundation</u> |
| | #6 | | <u>leaking smoke.</u> |

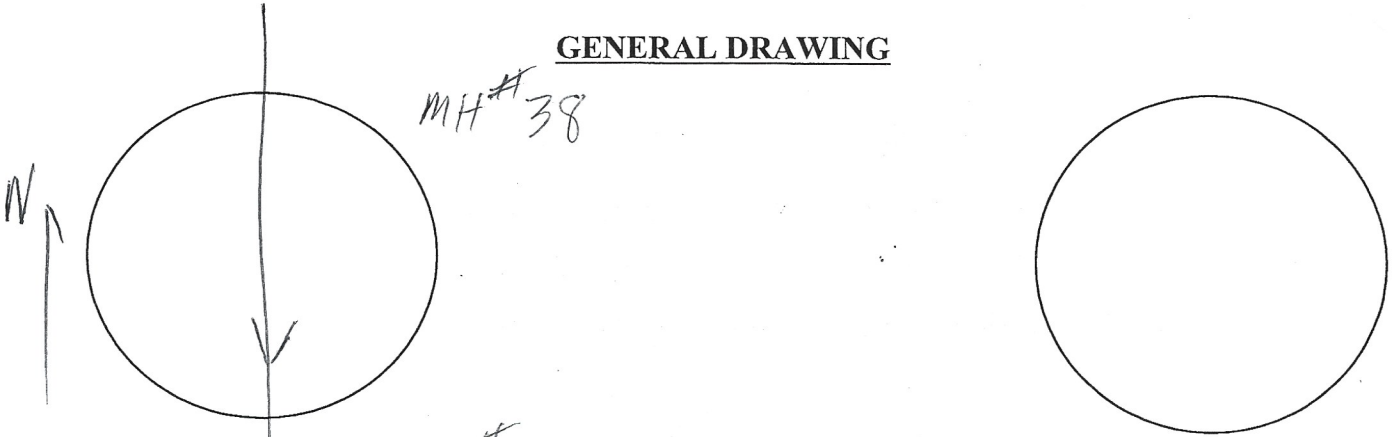
GENERAL DRAWING

| MH# | #1 | <u>MH # 38</u> | <u>to 107 N. Dameron C/O Leaks a little</u> |
| | #2 | | <u>S.E. Corner of House 1</u> |
| | #3 | | <u>2. 403 N. Dameron smoke in ear old</u> |
| | #4 | | <u>side walk over water service area</u> |
